Lime mortar v cement

Ian Pritchett of IJP Building Conservation discusses traditional methods for today's buildings

Lime cures the damp problems of the Parish Church of St James during a recent restoration.

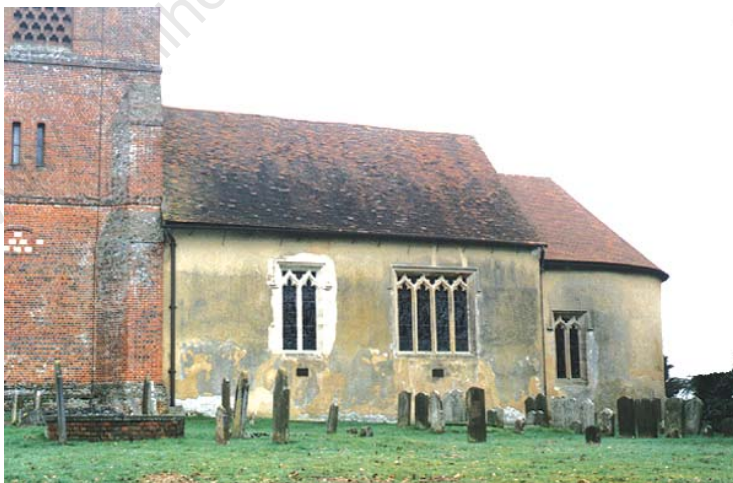
The church soon after work started

IJP carried out further investigations, establishing what previous finishes had been used on the building (in this case, lime render and lime washes), as well as the type and condition of the background structure and probable ease of removing the existing render. From this initial investigation IJP then stripped off all of the existing sand and cement render, revealing areas of loose masonry and many deep voids.

It was necessary to dub out the masonry, incorporating new flint and hand-made clay tiles with a fat lime mortar to fill the voids. The resulting process gave a flush and level surface on which the new lime render would be applied.

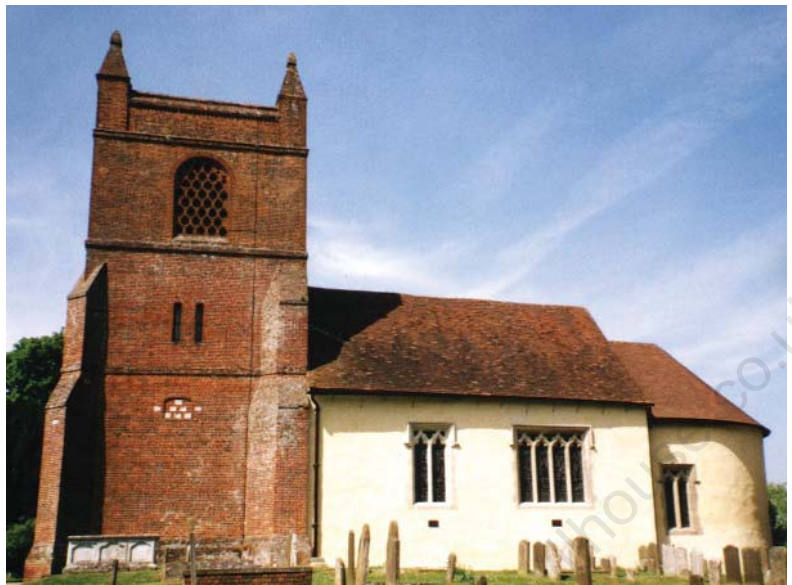
The church after completion of the work

IJP applied a two-coat render scheme, using haired fat lime, following the undulations of the base wall. On top of this base coat, four coats of lime wash were applied with a yellow ochre pigment. A number of the church windows also needed attention. Minor mortar repairs were made to improve the weathering details of the masonry. A lime shelter coat (a mix of lime putty and silver sand) was applied onto the surface of the stone.

The results speak for themselves. The external appearance of the church has been altered and now looks much as it would have done for the majority of its life. IJP has reversed the well intentioned, yet damaging effects, created by the use of modern materials, now creating the conditions needed to protect the building for centuries to come. Parishioners now have a church which is a lot more healthy - and pleasant to look at.
